STATOR SERVICE ISSUES

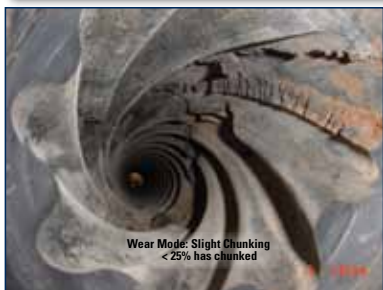
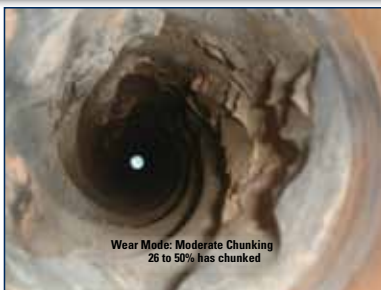
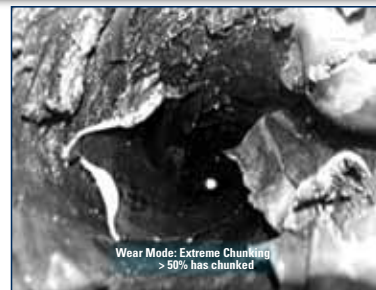
Chunking Chunking Chunking

Chunking occurs when the elastomer has been over-loaded and has fatigued, tearing away from itself.

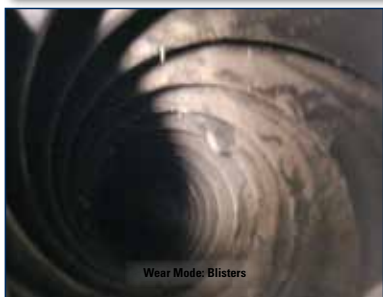
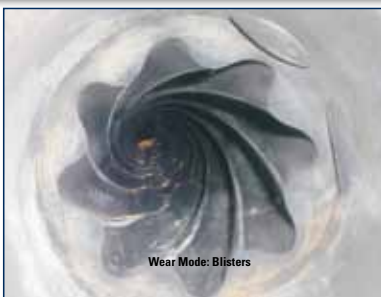
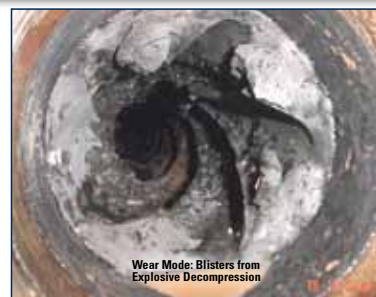
Blisters Blisters Blisters

Air bubbles or "blisters" seen on the surface of the elastomer. They are caused by gas absorbed by the rubber under pressure and the pressure is released quickly, causing explosive decompression.

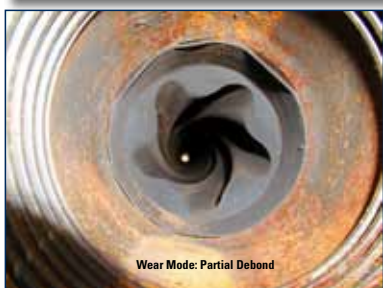
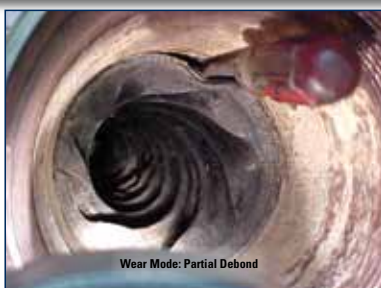
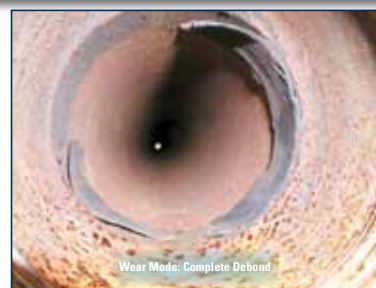
Debond Debond Debond

Debonding is a failure of the adhesive between the rubber and the bond surface.
