Another successful run with a PV power section!!

When: April 04 - 10, 2015
Where: Mountrail County, North Dakota

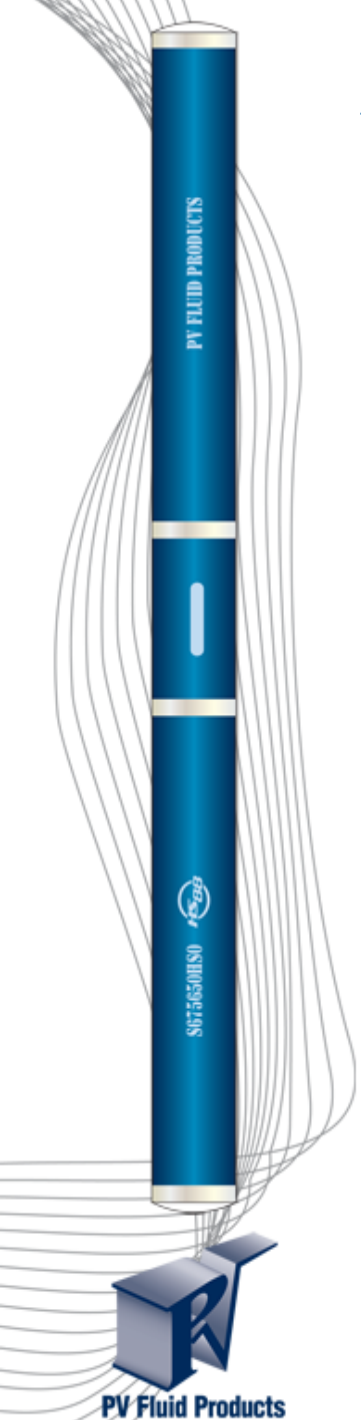
WinSURV II Mud Motor Report

Time and Depths (This BHA)		MOTOR DATA		Drilling Parameters	
Date In:	04-Apr-15 @ 16:45	Desc:	5 inch; 6/7; 8.0 stg; 2OS; set @	SO/PU:	110 - 150 / 165-210
Date Out:	10-Apr-15 @ 20:00	MFG.:		Rot Wt:	155-170
Hrs In Hole:	136.42	BHA Circ/ All BHA:	96.58 / 96.58	WOB:	5 - 80
Start Depth:	11173.00	Motor SN:		TORQ:	4000 - 15000
End Depth:	21160.00	Pad OD:	.125	SPP:	2050 - 4550
Total Drilled:	9987.00	NB Stab:	0	Motor RPM:	223 - 248
Avg. Total ROP:	110.25	Bit to Bend:	3.99	Rotary RPM:	25 - 70
Circ Hrs:Tot/Only:	96.58 / 6.00	Bent Hsg / Sub:	1.5 / 1.5	Flow Rate:	236 - 306
Percent Slide:	8.24	Lobe/Stage:	6/7 / 8	Avg Diff:	1000
Percent Hrs:	35.97	Rev/GAL:	0.81	Stall Pres.:	1800
Slide Hours:	32.58	Rotor Jet:	0	Off Bot Pres.:	3400
Total Sliding:	823.00	Prop BUR:	12	Bit Record	
Avg. Slide ROP:	25.26	Act BUR:	14	SECURITY / Security MM64	
Percent Rotary:	91.76	Stator Clearance:	.008	Run #:	3
Percent Hrs:	64.03	Lower Stab OD:		Type Bit:	PDC

Rot / Total Hrs:	58.00 / 90.58	Upper Stab OD:		IADC#:	TFA: 1.841
Rotary Drilled:	9164.00	Extended Motor? NO		JETS:	e-20
Avg. Rotary ROP:	158.00	Number of Stalls:	0	Bit Drop:	25 PSI @ 306 GPM
Reason POOH:	TD	Stall Duration:	0	Cond.:	2;4;WT;S;X;CT;TD
Mud Data					
Type	Salt water	WT:	9.7	Vis:	28
SAND:	0	Chlor:	150000	GAS:	0
		SOL:	0.5	Oil %:	1
		YP:	1	PH:	9
				Flow T :	0
				Bottom Hole T :	252
Formation:					
EXPANDED REASON PULLED:					
TD lateral.					
BHA PERFORMANCE:					
(Rotating-Drilled 9164' @ Avg. ROP of 158, DIFF: 500-1150, WOB: 15-30, RPM: 55-70)(Sliding- Drilled 823' @ Avg. ROP of 25.26, DIFF: 100-250, WOB: 20-50)					
ADDITIONAL COMMENTS: (Expands to next page if necessary) Assembly drilled as expected, giving great ROP, and consistent build rates. Bit was easy to steer, but did not track very well. Upon reaching surface the motor drained fine and no excessive play was noticed, motor will be sent in for further inspection. Bit was graded: 2;4;WT;S;X;CT;TD

- Model - 5" 6/7 lobe 8.0 stage
- Stator Minor – 2.639
- Fit In - .004" loose
- Rubber - HS88
- BHT - 252° F
- Mud Type - Salt Water
- Hours in Hole - 136 hrs.
- D&C Hours - 96.58 hrs.
- Total Drilled - 9,987'
- Avg ROP - 110 ft./hr.
- GPM - 236 – 306
- Avg Differential - 1,000 psi
- Reason POOH - TD
- Customer Feedback – Exceeded expectations of 2,000' drilled/day
